10 major detainable deficiencies

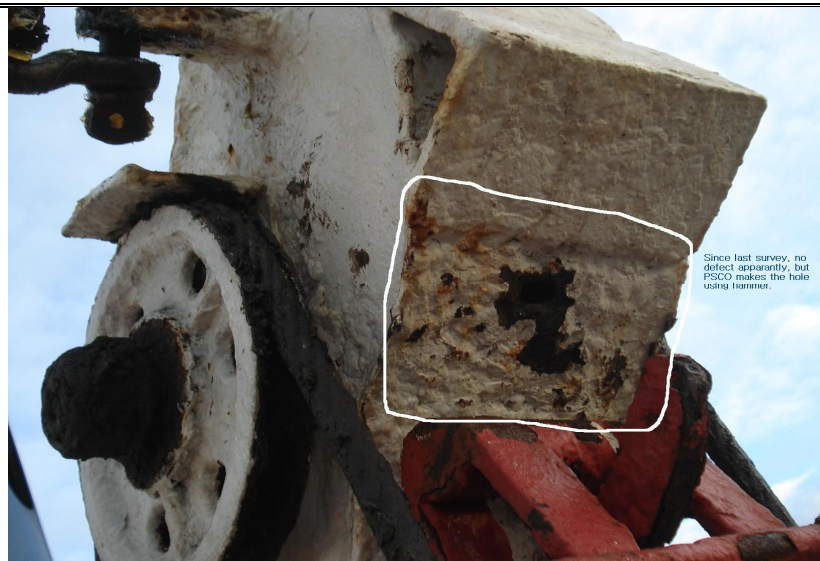
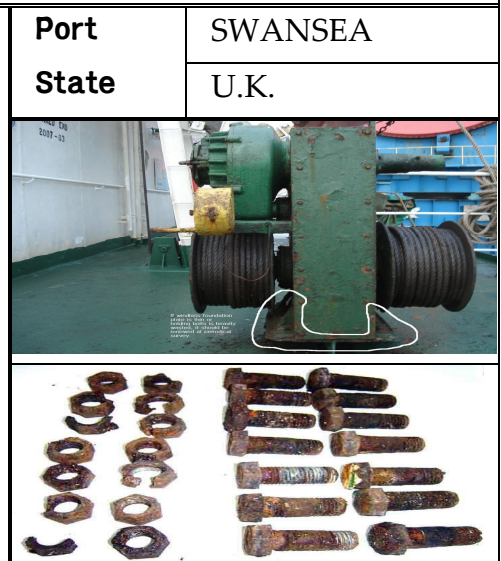
1. Corrosion and holes on Launching Appliance

- Corrosion on davit and foundation, which had been covered by paint coating.
- The coat of paint covering suspect area shall be removed for inspection.
- Bolt/Nut to be renewed as the evidence of repair, if necessary.

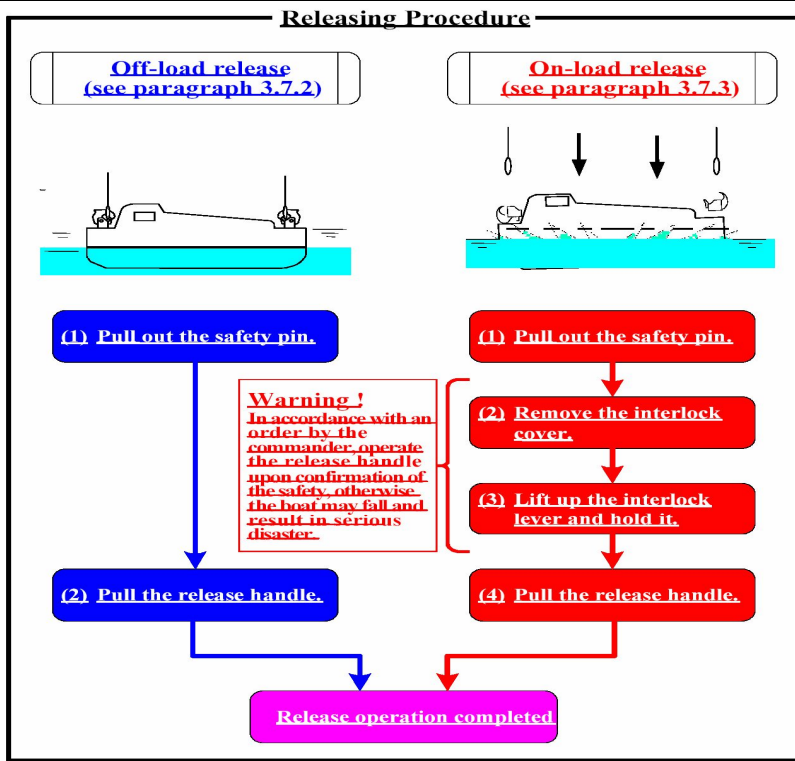
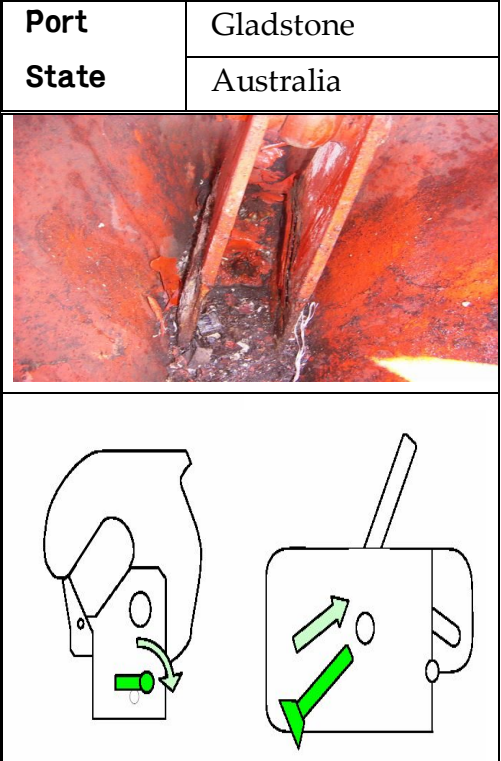
2. Poor condition of Launching arrangements

- Inspection after removing the lifeboat inventory and the scale near the bracket.
- Working and set condition of On-load release gear system to be inspected.
- Close-up inspection on conditions of Block Sheave, Joint Shackle, etc.

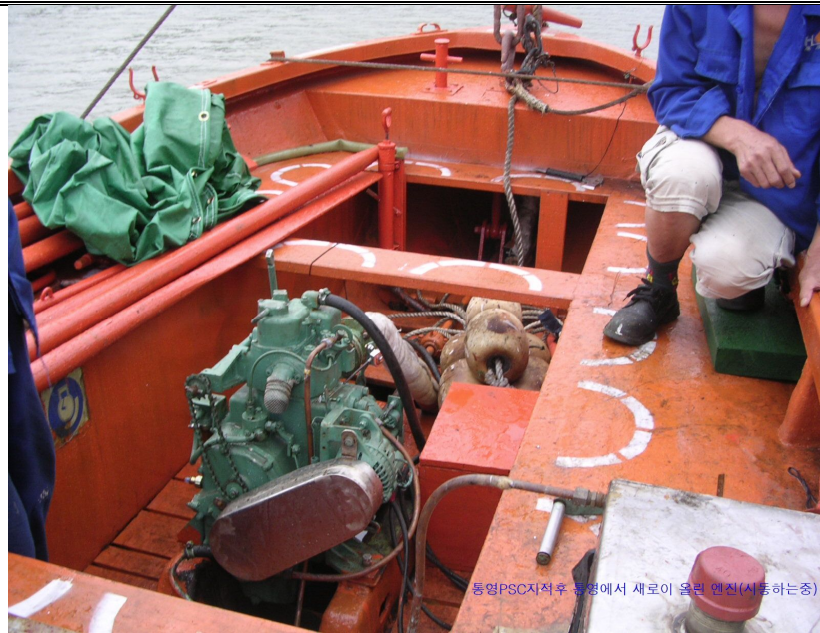
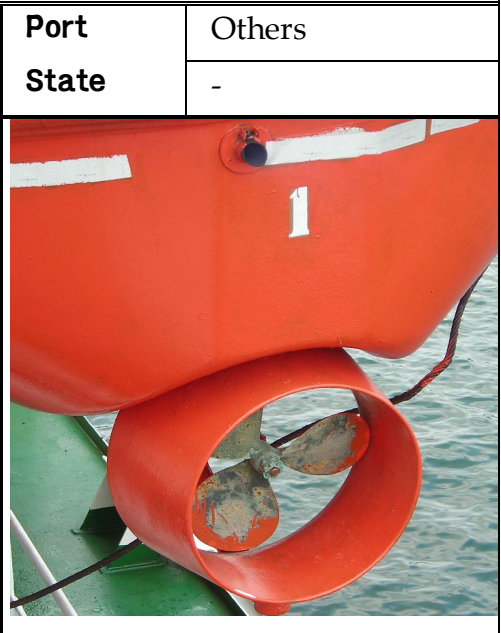
3. Malfunction of Life Boat Engine

Inspection Point	➤ Confirmation of engine on each lifeboat to be started by one person
	➤ Cleaning of the F.O.T for removal of residue inside
	➤ Inspection on the chain condition, if necessary
	➤ Conducting the propeller test (Fwd/Aft direction)

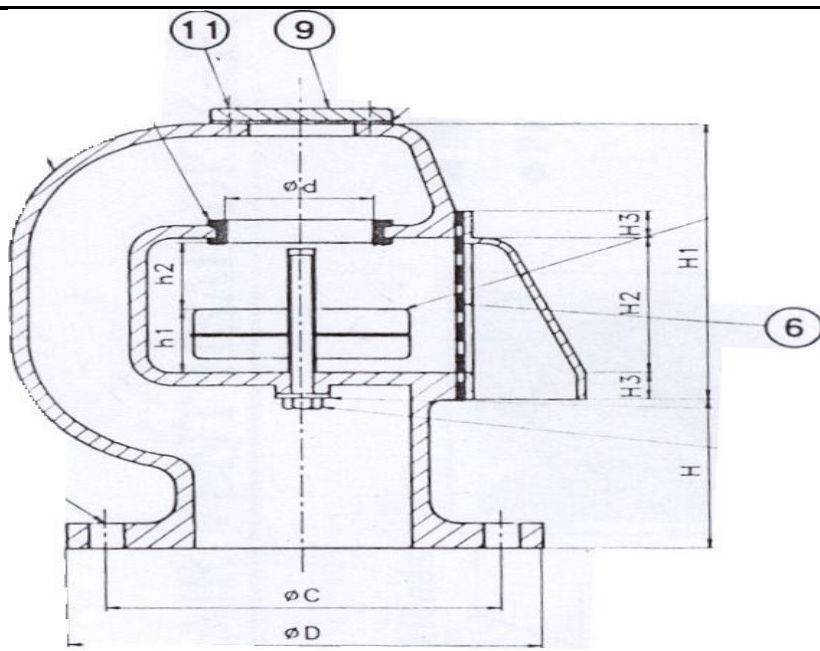
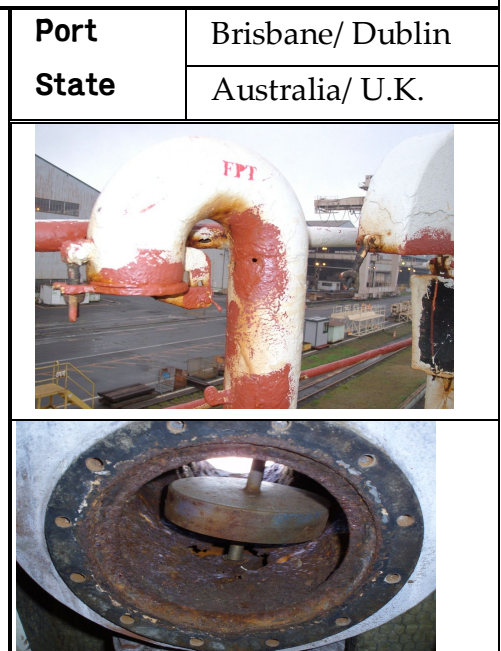
4. Poor condition of Air Vent Head

Inspection Point	➤ Inspection on the inside of Air Pipe Head conditions by removing the Cover
	➤ Check on the Pipe condition on exposed deck (corrosion, hole, etc.)
	➤ Check on cover-tightness for Gooseneck Type

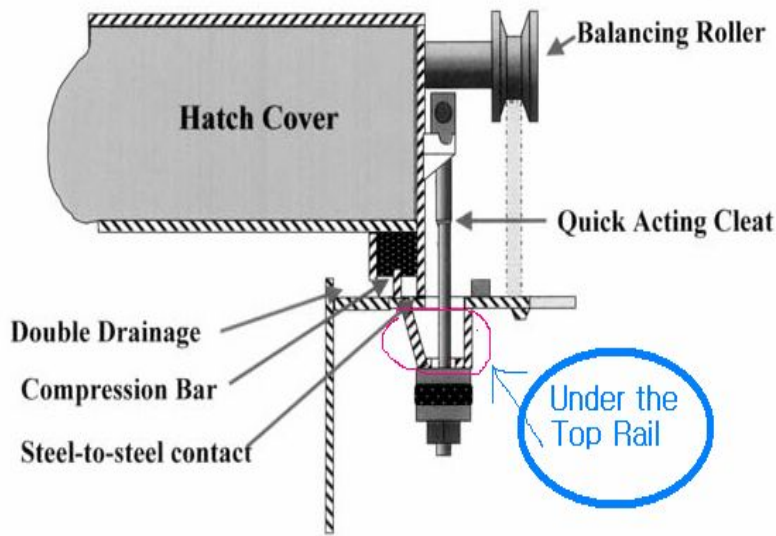
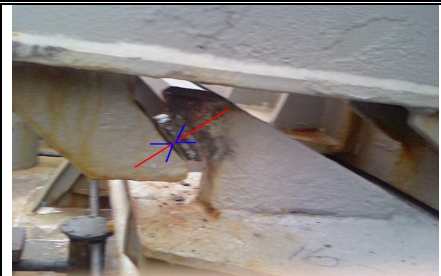
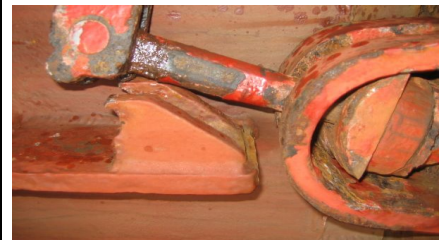
5. Corrosion on Hatch Cleat Secure Socket

| Inspection Point | <ul style="list-style-type: none"> ➤ Check on the weather-tightness of hatch covers (hose test, if necessary) ➤ Check on the condition of Top Rail and the Cleat Socket installed below ➤ Cleat clearance to be checked, especially for Auto Cleat Type

(Ex. Maker Standard for MacGREGOR type is to be less than 3 mm) |

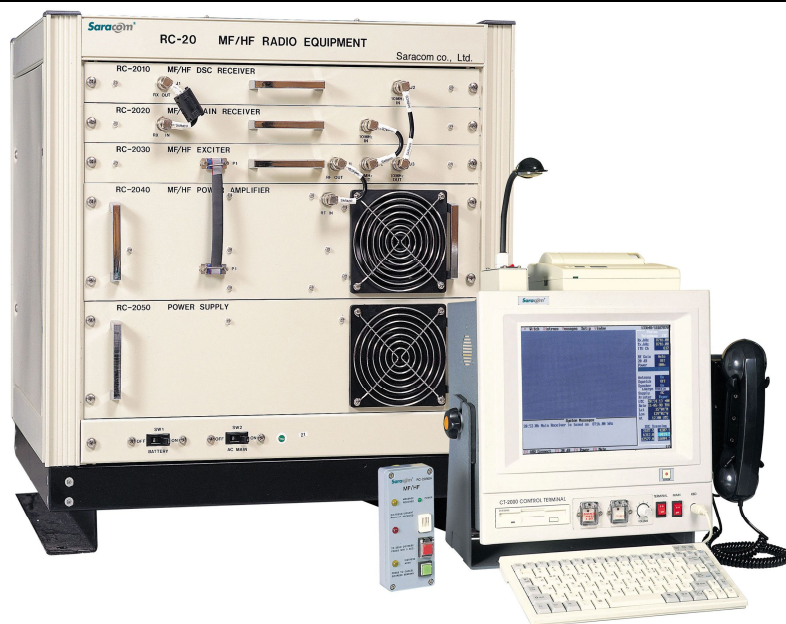
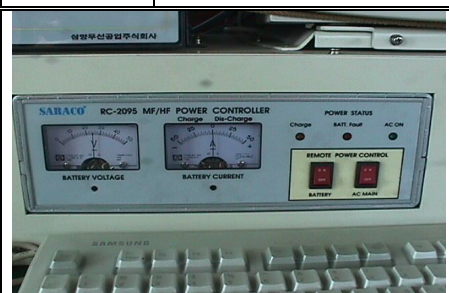
6. Malfunction of GMDSS Equipment

| Inspection Point | <ul style="list-style-type: none"> ➤ Record for MF/HF DSC messages(BQ/RQ) to be available on board ➤ GMDSS equipment readiness for receiving relevant information to be checked ➤ Functioning test of reserve energy source (DC / Battery) for GMDSS equipment to be conducted |

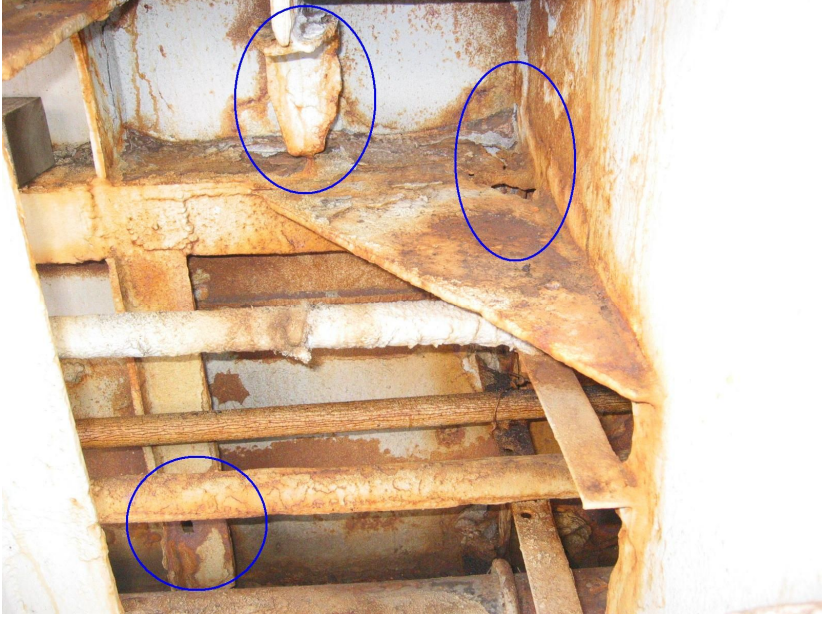
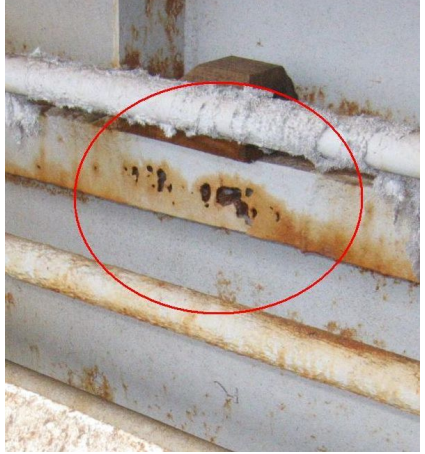
7. Corrosion and hole on Hatch Coaming Stiffener

Inspection Point	<ul style="list-style-type: none"> ➤ The original thickness to be checked, and the wear-down limits to be compared with measured one, if necessary ➤ Local area with holes to be inspected ➤ All deficiencies found during the Survey to be rectified before departure

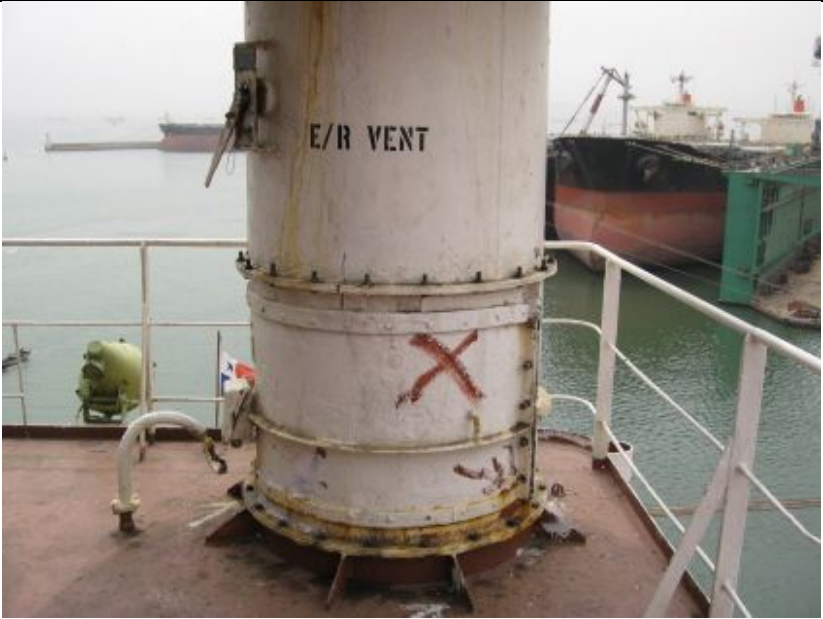
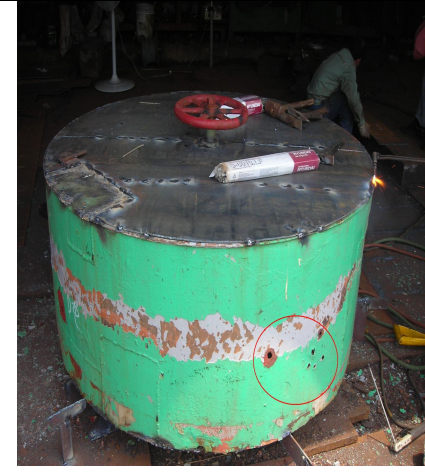
8. Poor condition of Fire Damper/ Ventilator

Inspection Point	<ul style="list-style-type: none"> ➤ Operation of moving parts for dampers to be checked (not to be stuck) ➤ Damper condition located inside ventilator to be examined through lowering head with lantern or removing cover (corroded due to temperature difference) ➤ Vent pipe to be inspected with removing scale, and inside of pipe, if necessary

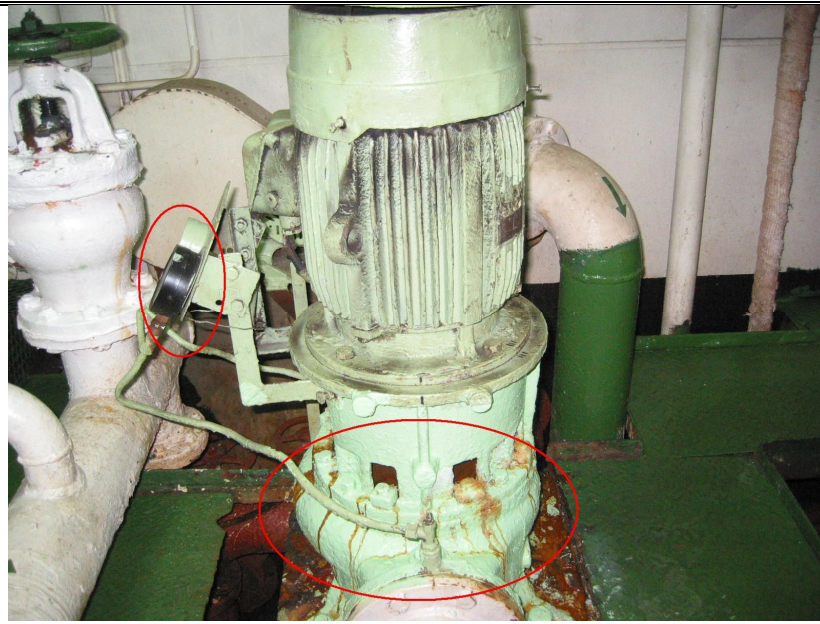
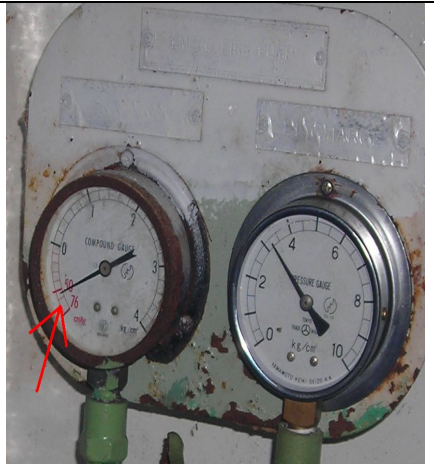
9. Malfunction of Em'cy Fire Pump

<p>Inspection Point</p>	<ul style="list-style-type: none"> ➤ Suction pressure (over -50Bar), Delivery pressure (3Kg/Cm²) to be checked ➤ Capable of delivering at least two required jets of water, in any case ➤ Running the pump more than 5 minutes with maximum pressure
--------------------------------	--

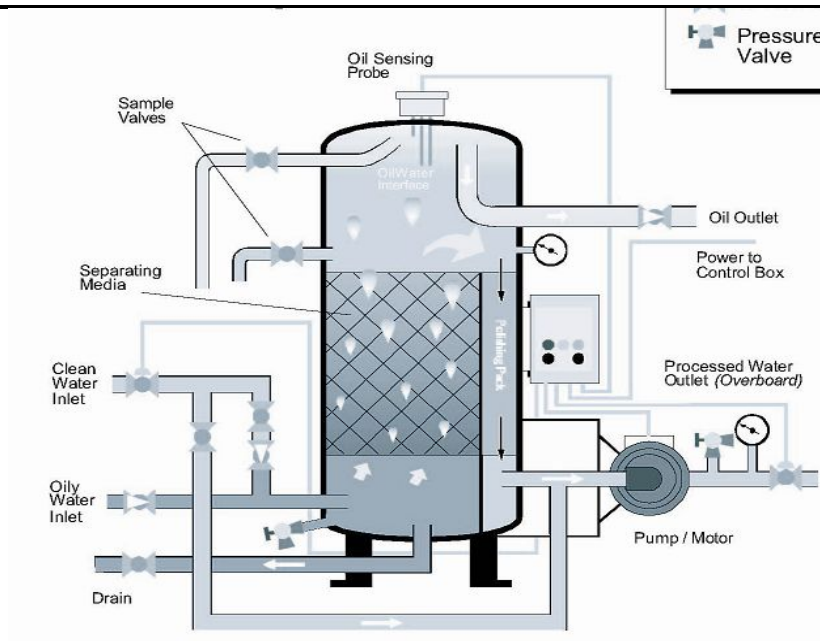
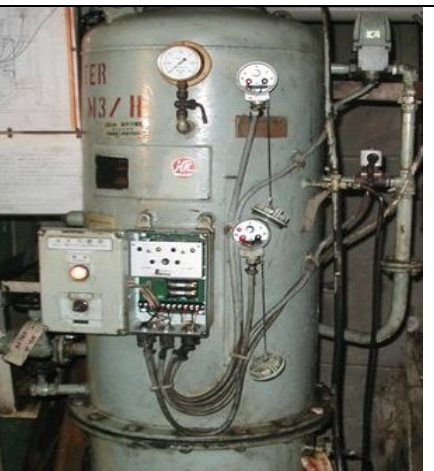
10. Malfunction of OWS

<p>Inspection Point</p>	<ul style="list-style-type: none"> ➤ Functioning of bilge alarm, oil level detector to be checked ➤ Oil existence inside the disassembled overboard outlet to be checked ➤ Functioning of oil discharge valve, three-way valve to be checked.
--------------------------------	--
