**ΠΡΟΓΡΑΜΜΑ ΜΕΤΑΠΤΥΧΙΑΚΩΝ  
ΣΠΟΥΔΩΝ**

**ΚΑΤΗΓΟΡΙΟΠΟΙΗΣΗ ΚΑΙ ΜΕΛΕΤΕΣ  
ΠΕΡΙΠΤΩΣΕΩΝ ΝΑΥΤΙΚΩΝ  
ΑΤΥΧΗΜΑΤΩΝ**

**Διπλωματική Εργασία**

**Ιανουάριος 2015**

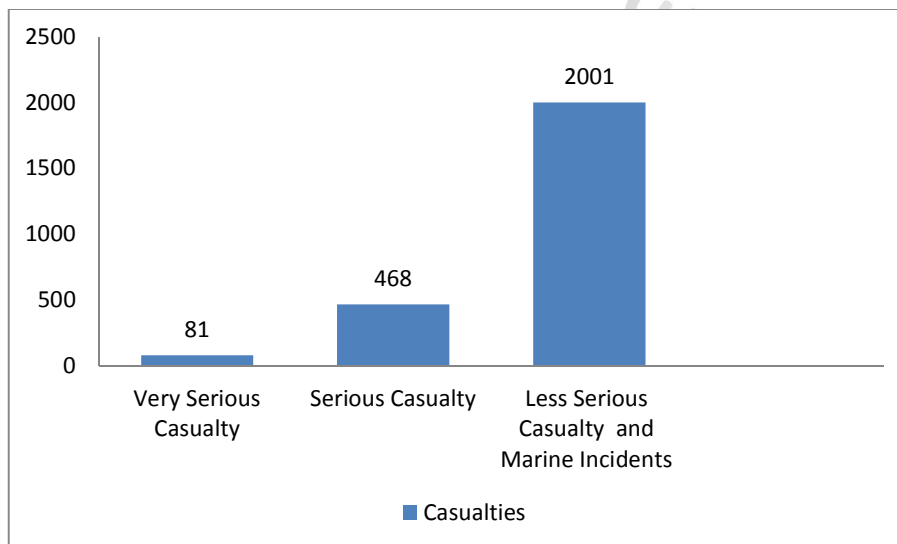
**Chart 4.1: Level of severity of Marine Casualties in 2013. (Source: [www.emsa.europa.eu](http://www.emsa.europa.eu) )**

In the chart above, the less serious casualties have been combined with the marine incidents. In the first category of very serious casualties are including accidents with a total loss of the vessel, loss of human life or very serious damage to the environment. As serious casualties here are included accidents of fires, collisions, groundings, heavy weather damage, that have resulted in pollution or disability for the ship. The third category is about all the other casualties that they are not considered as serious. In percentages, only 3,6% of all accidents that were reported were classified as very serious, 18,1% were serious and 78,3% were less serious and marine incidents. The total number of marine occurrences (both marine accidents and incidents) in 2013 was 2.550 and the average number of accidents per month was 212.

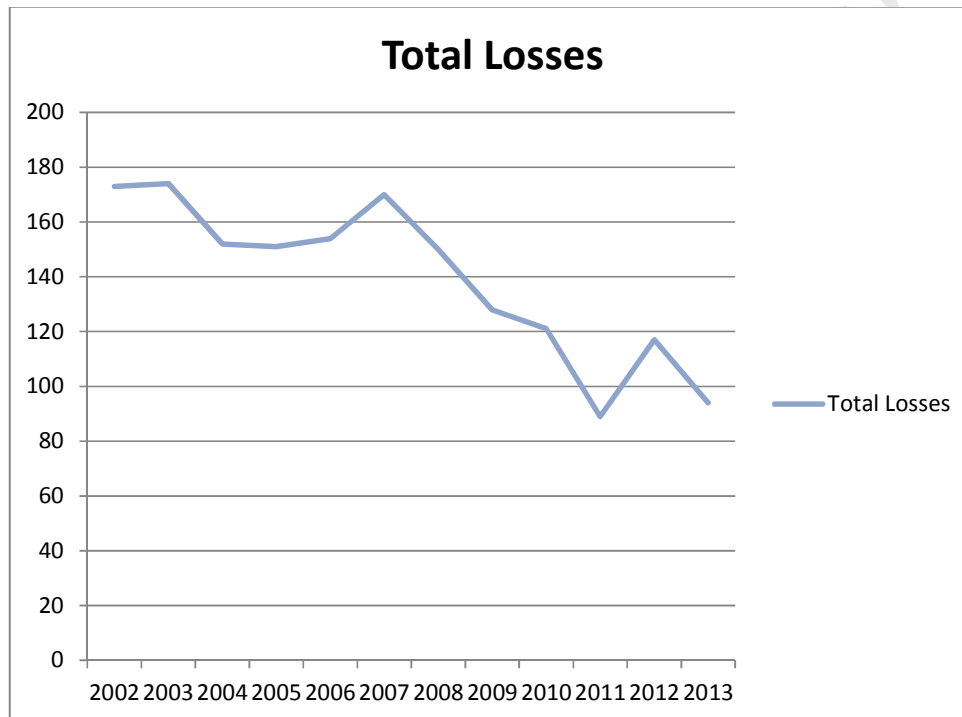
The total number of ships involved in the marine casualties during 2013 was 2.872. The total large vessels' losses that were reported during the past year were 94. This number represents a significant reduction, as the annual total dropped under 100 for the second time in 12 years. Moreover, in comparison to 2012 where the total losses reached 117, we have a 20% decrease and throughout the last ten years, that means from 2003, the shipping losses have declined by 45%. The graph below represents this declining trend.

**Chart 4.2: Total Losses by Year [2002-2013] (Source: [www.agmc.allianz.com](http://www.agmc.allianz.com))**

The reduction that is presented above is a proof that the attempts that have been made in order to prevent the occurrence of a marine accident have given back. Every year more lessons are learned from the previous casualties and more safety measures are taken in technological and organizational level. The aim is to keep this trend to a declining direction.

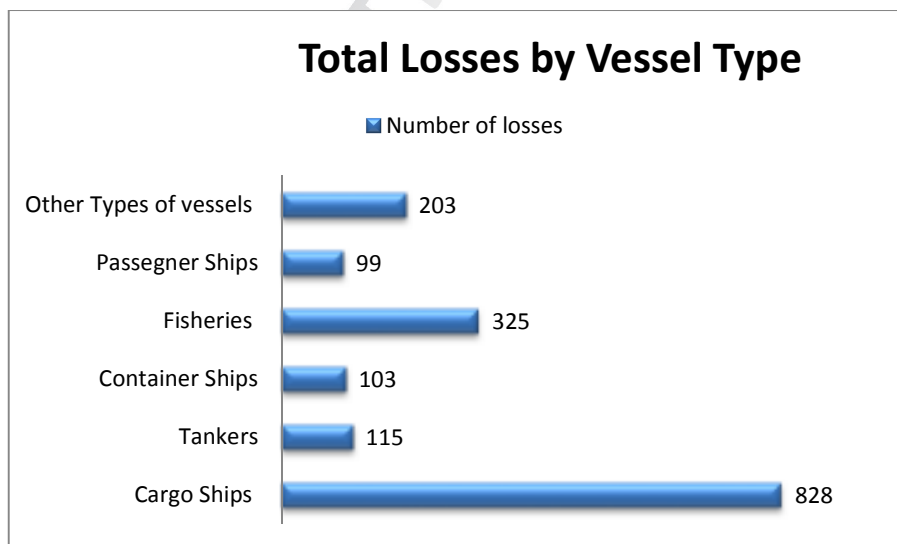
As we mentioned in a previous section, we categorize the marine casualties by the type of the vessel and by the type of the event. We are listing below a statistical chart with number of marine accidents by vessel type for the last 12 years (2002-2013). In total we had 1.673 losses.

**Chart 4.3 : Total Losses by Vessel Type 2002-2013**

As we can deduce from the two above bar charts, the cargo ships are the most common vessel type to be involved in marine accidents. This fact arises questions about how secure is the storage of the cargo and if the loading limits are passed or not. Second come the fisheries, where main reasons like crew fatigue, presence of dangerous machinery, failure to provide protective equipment result to the above numbers. Tankers, container ships and passenger ships come next in line.

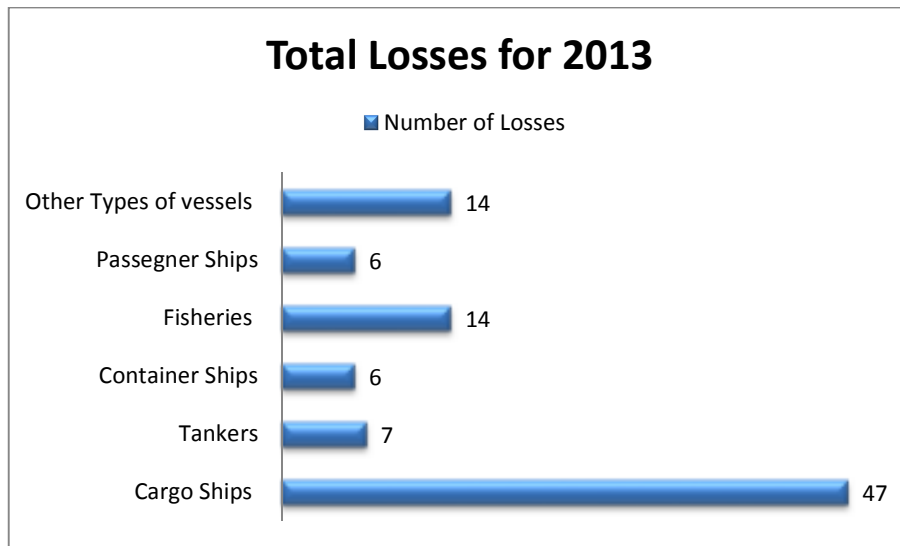
**Chart 4.4 : Total Losses for the year 2013**

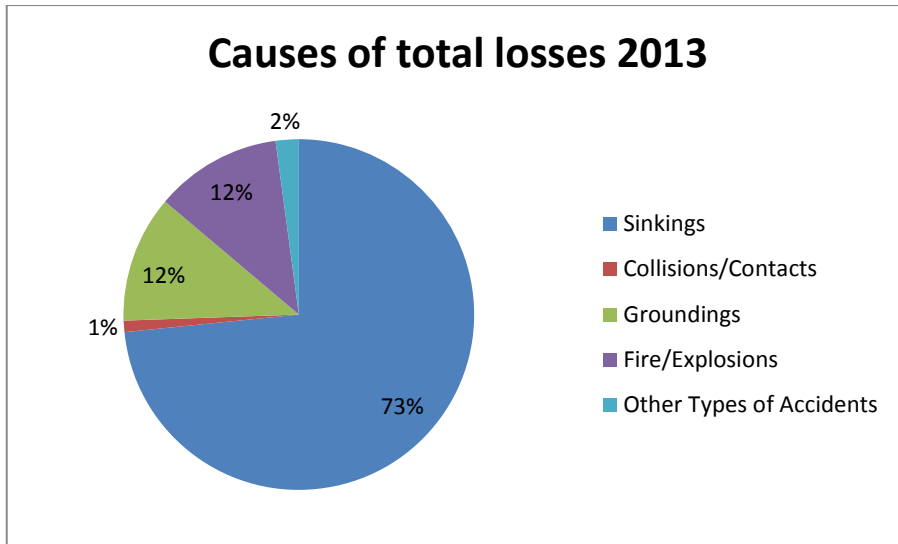
The second pie shows the statistical percentages for the last year 2013. As we have mentioned before the total losses last year were 94.

**Chart 4.6: Causes of total losses for the year 2013 (Source: [www.agmc.allianz.com](http://www.agmc.allianz.com))**

As we can see, the biggest percentage is a courtesy of the sinkings. Groundings and fires/explosions come to the second place, while the collisions in the third place. Not only for the last year, but also for the all years in the past decade! 2% of the category "Other Types of Accidents" refers to two in number losses of vessels. Both were caused by machinery damage/failure.

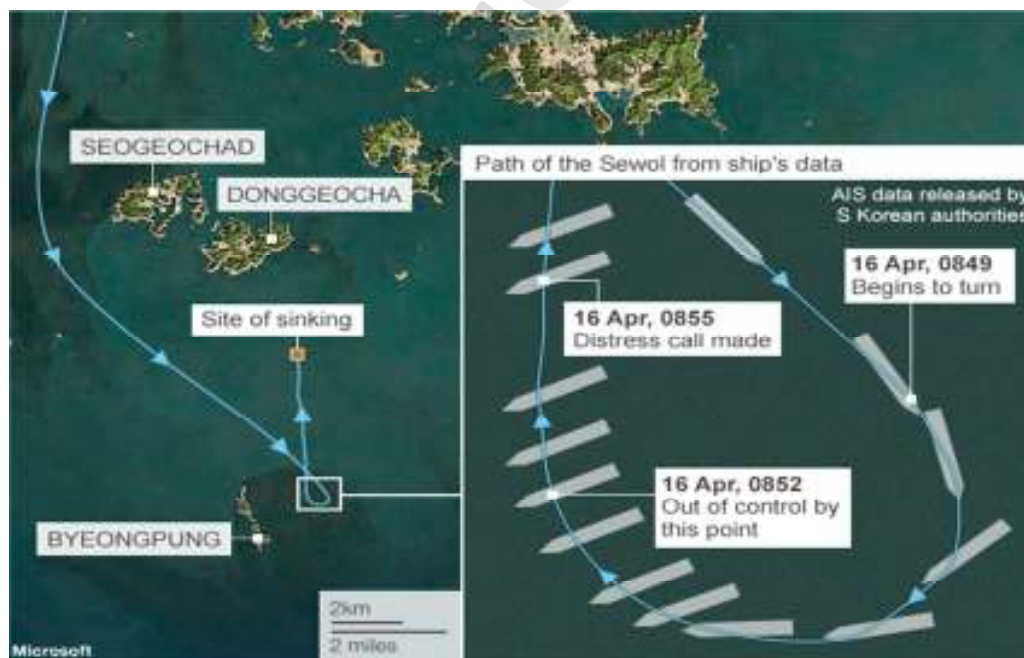
Sewol was following her usual course until the sharp turn. An inexperienced third mate was guiding and steered the ship. The sharp turn to starboard caused cargo to shift. That was the official cause according to the ROK (Republic of Korea) Coast Guard. The shifted cargo exceeded the ability of the ship to self-recover using ballast and trim tanks (Paul Bruno, maritime Expert, 2014). ROK Coast Guard also states in the official explanation that the AIS data confirms a sharp turn to starboard. AIS data is captured by outside receivers and there is no indication that the data from all sources is not identical <sup>[29]</sup>. This is nearly as good as virtual evidence of the sharp turn.

Map 6.2: Sewol's sharp turn (Source: [www.bbc.com](http://www.bbc.com))

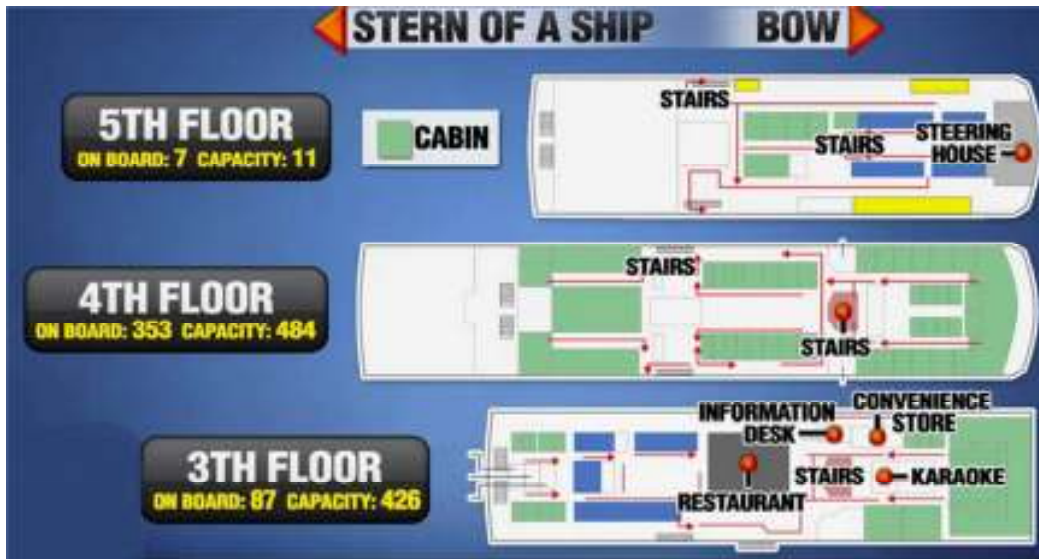
Investigators want to know if the renovations may have made the ferry more likely to capsize or raised the ship's center of gravity. The South Korean Ministry of Oceans and Fisheries announced in late April that it would ask lawmakers to consider legislation prohibiting modifications to ships to increase passenger capacity. The government plans to take away the company's licenses for all its routes, including the one on which the Sewol sank, according to an official at the ministry <sup>[33]</sup>. Below there is a picture showing the capacity of the vessel for decks no 3,4 and 5 after the modification.

Image 6.3: Sewol's capacity. (Source: [www.boatdesign.net](http://www.boatdesign.net))
